**REPAIR, EVALUATION, MAINTENANCE, AND
REHABILITATION RESEARCH PROGRAM**

TECHNICAL REPORT REMR-CO-7

**METHODS TO REDUCE WAVE RUNUP AND
OVERTOPPING OF EXISTING STRUCTURES**

John P. Ahrens

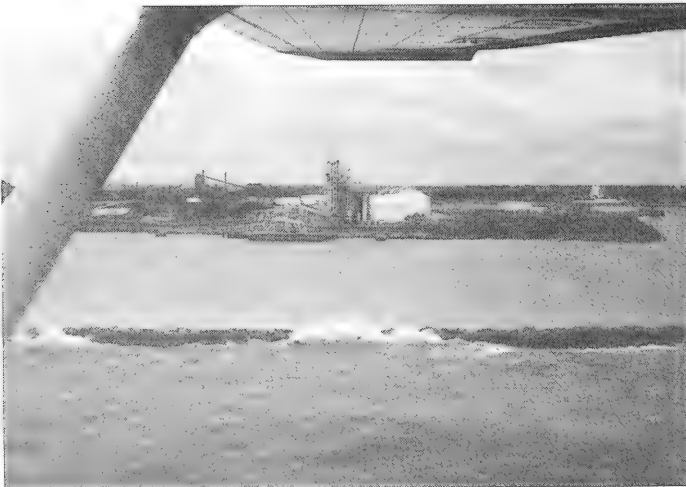
Figure 8. Wave action against breakwater at
Burns Harbor, Indiana, April 1986

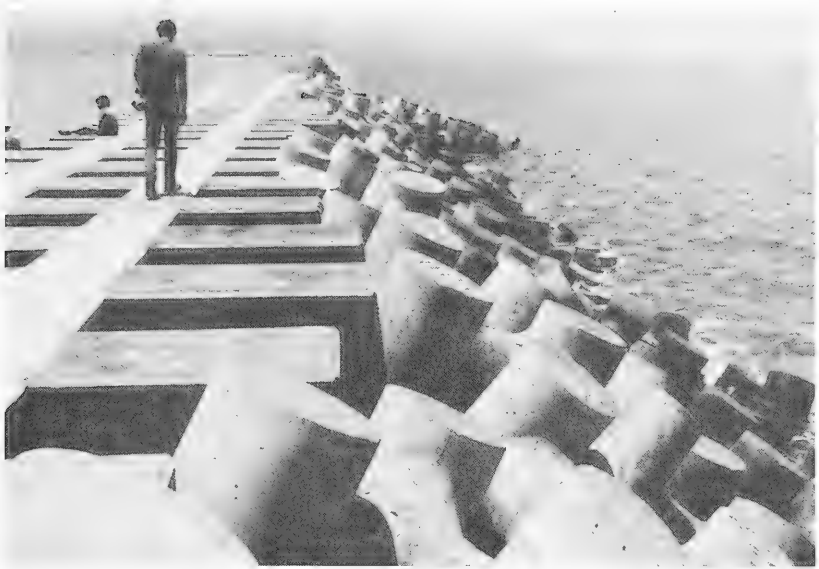
Figure 9. Rib cap on breakwater at Hilo, Hawaii

13. A physical method developed within the US Army Engineer Division, Pacific Ocean, to cope with crown stability and overtopping during heavy wave overtopping of rubble mounds is a ribbed concrete cap. Concrete armor units key into the ribs and improve the stability of the crest, and the presence of the ribs adds resistance to wave overtopping flow thereby reducing transmission (Markle 1982 and Markle and Herrington 1983). Figure 9 shows the concrete rib cap on the breakwater at Hilo, Hawaii. The reef transmission model is not applicable to concrete cap breakwaters without further experimental work.

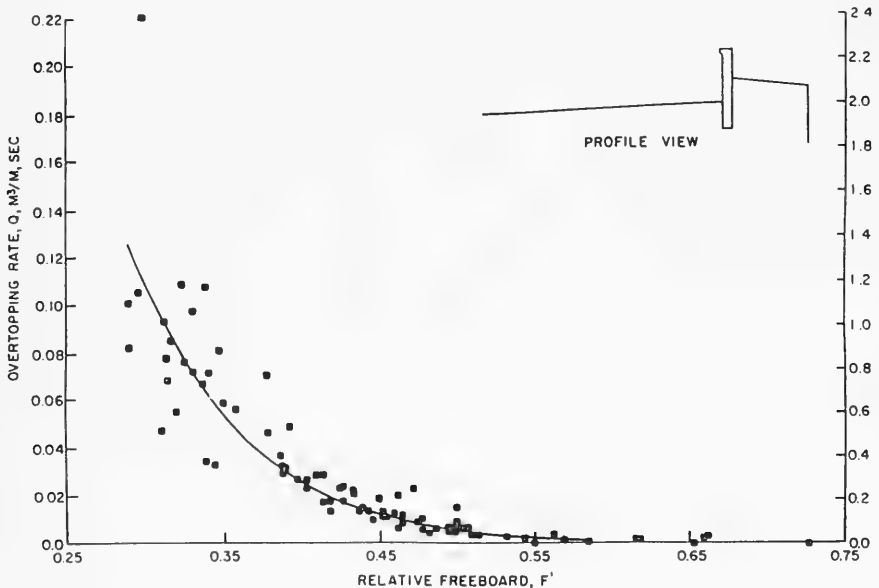
Figure 10. Overtopping rate versus relative freeboard for the Roughans Point seawall with no revetment (configuration RP-1)

17. A very valuable characteristic of the freeboard parameter is that it combines a lot of information about the structure, water depth, and wave conditions into one variable. The parameter F' has higher correlation with the overtopping rate for the Roughans Point data than any other parameter which could be identified, including the parameter F/H_{mo} , suggested by the work of Goda (1969) and Seelig (1980) or the dimensionless freeboard parameter $F/(T_z^2 g H_s)$ used by Owen (1982b), where T_z is the zero-crossing wave period, g is the acceleration of gravity and, H_s is the significant wave height of the spectrum. Figure 10 shows a plot of the overtopping rate as a function of

F' for the existing seawall configuration at Roughans Point without a riprap revetment protecting the wall. Considering the complexity of the irregular wave overtopping process, the ability of F' to consolidate the overtopping data into a well-defined trend is surprising.

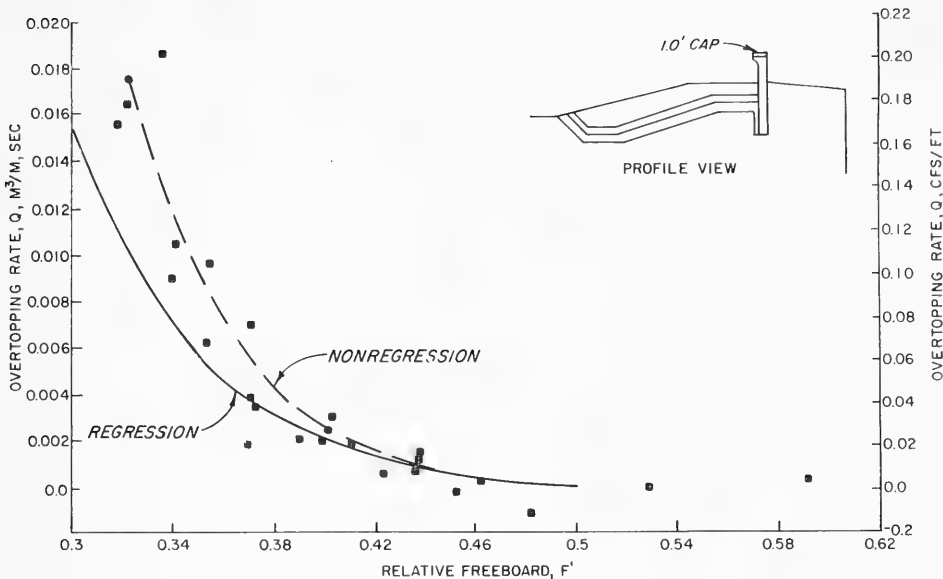
Figure 11. Overtopping rate versus relative freeboard for the Roughans Point seawall fronted by a wave absorber revetment with a berm and a 1.0-ft cap on wall (configuration RP-7)

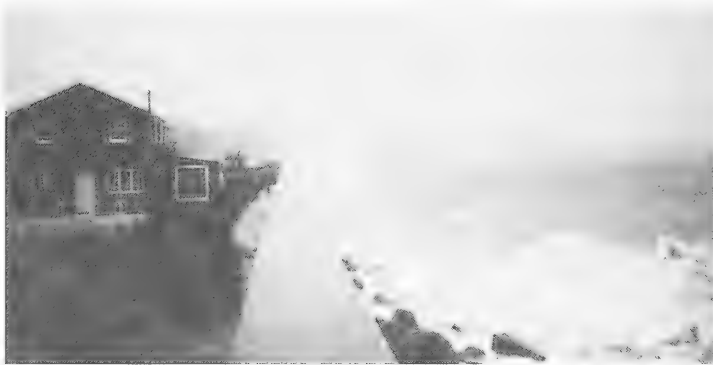
Figure 12. Wave overtopping the seawall at
Roughans Point, Massachusetts

21. One method to reduce wave overtopping is to use a recurved wall instead of a vertical wall. The Roughans Point seawall is vertical with a small recurve at the crest. Observations indicate that the recurve is effective when the waves are small enough and the water depth at the wall great enough to allow a reasonably coherent standing wave system to be established. This system causes a vertical flow regime at the wall which is thrown seaward by the recurve (Figure 12). The recurve is not effective when the crest

height of the incident wave approaches the elevation of the crest of the seawall because the large, partial clapotis which forms for a moment in front of the wall then spills over in large volumes of "green" water literally inundating the seawall for a short time.

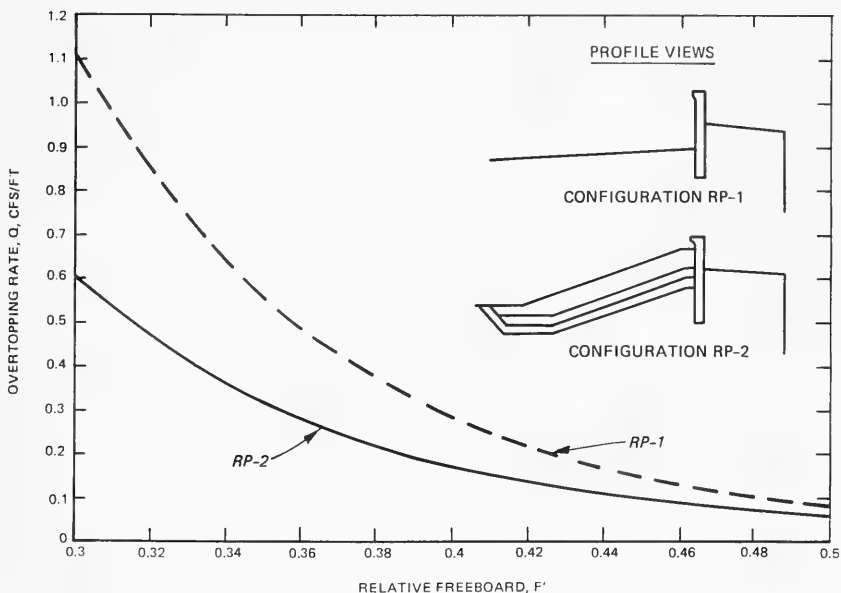
Figure 20. Comparison of overtopping trend curves for the Roughans Point seawall with no revetment (configuration RP-1) and the same seawall fronted by a standard riprap revetment (configuration RP-2)

25. During the Roughans Point study, a standard multilayered riprap revetment was built against the seawall with the top of the revetment near the top of the wall just below the recurve. The revetment reduced the overtopping rates by about 45 percent over the same seawall configuration without a revetment. Figure 20 shows a comparison of the performance of the two configurations using data trend curves developed from regression analysis. Standard riprap revetment was found to be less effective in reducing overtopping than was originally thought. Two possible reasons for the disappointing performance of the riprap were identified:
